Comparison of Different Cemented Tungsten Carbides Applied to Particleboard Machining End Mills

F. Jorge Lino^{1,2}, João Guimarães¹, Luís Teixeira², A. Monteiro Baptista², Tiago Fernandes³, Fernando Figueiredo³*

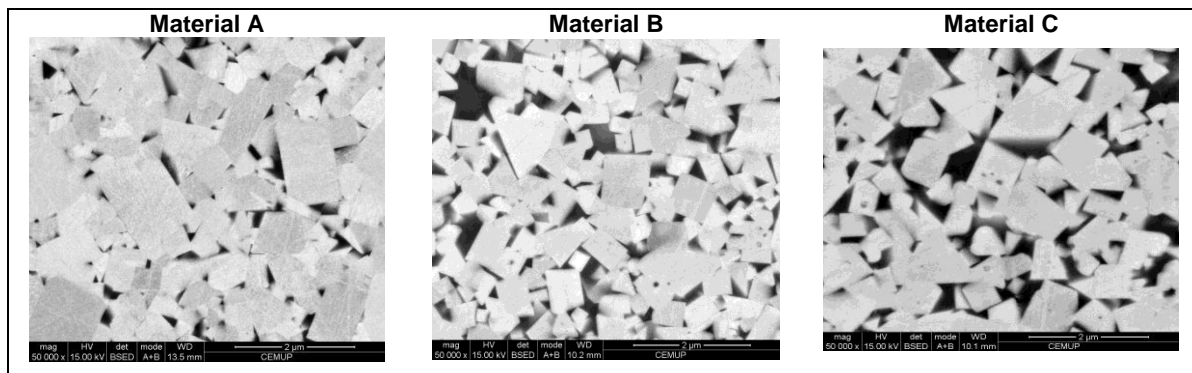
The microstructure is different in the three specimens, as shown in Fig. 2, where it is visible the lower grain size of Material B and the smaller binder content of Material A.

Fig. 2 - Microstructures of the studied materials.

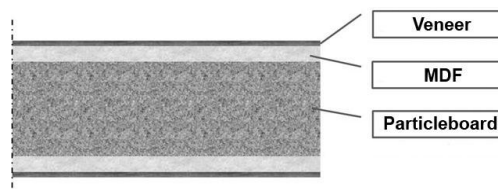
The machining process involved doors manufacturing in an industrial environment. The panel composition is mainly a particleboard with other plate attachments to ensure specific characteristics to the door application. The constitution of the boards to machine, as shown in the Fig. 4, is a 28 mm thickness particleboard together with two thinner plates of MDF, 3 mm each, with a veneer finish, varying its specific weight between 540 and 560 kg/m³ for all the tests. This small variation is consequence of working directly with the industry where sometimes certain variables are not restrainable.

Fig. 4 - Schema of the door board constitution.

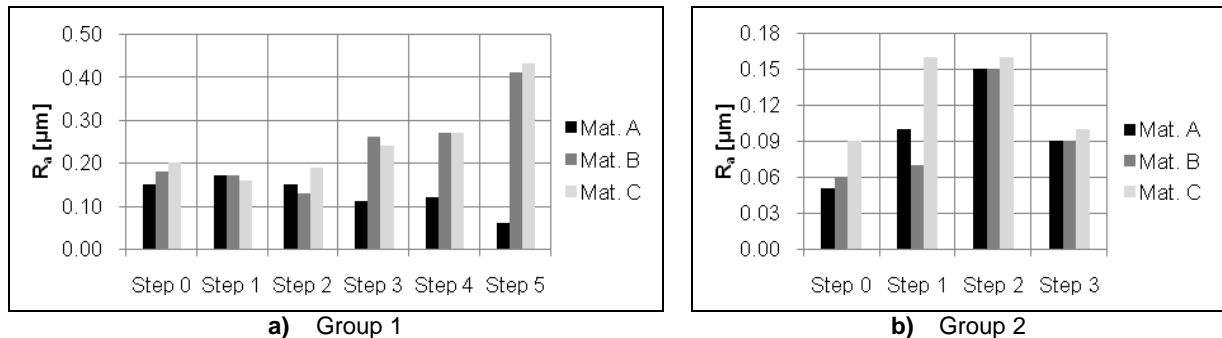
Fig. 5 – R_a – Arithmetic Average Roughness on the: a) Up surface flute; b) Down surface flute.

Fig. 5 a) shows a growing R_a evolution for the materials B and C due to its wear, but at the same time, the Material A evolves in opposite direction, denoting a polishing process. Fig. 5 b) has some similarities with a), and two aspects are relevant: the step 3 shows an equivalent surface state of the 3 materials, and also a decreasing from the previous step; the Material A shows an ascending roughness evolution along the steps, as opposite to the results shown in a). There were some peaks on the registered measurements, caused by measuring in places where would have occurred some defects such as a grain removals or scratches provoked by hard debris present in the boards.

The roughness measured along each step was registered with the parameters R_a , R_z and R_{max} for all the flutes and some surfaces.

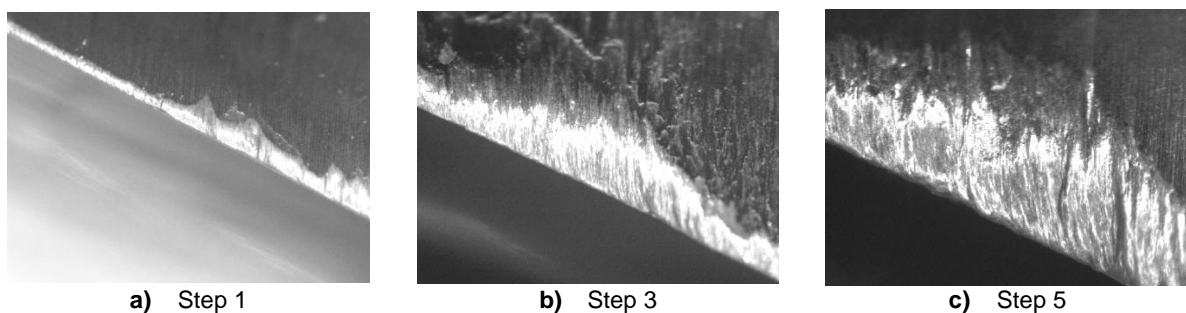
The visual inspection was very important due to its clear information and comparison along the tests. Fig. 6 shows the evolution of the *Up-cut* edge of the Material A end mill. It is visible the exaggerated wear after the step 5.

Fig. 6 - Macrographs registration of the evolution of the edge UP of the Material A - Group 1.
